LONDON- WEST MIDLANDS ENVIRONMENTAL STATEMENT

CFA24 | Birmingham Interchange and Chelmsley Wood

Survey reports (CH-004-024)

Cultural heritage

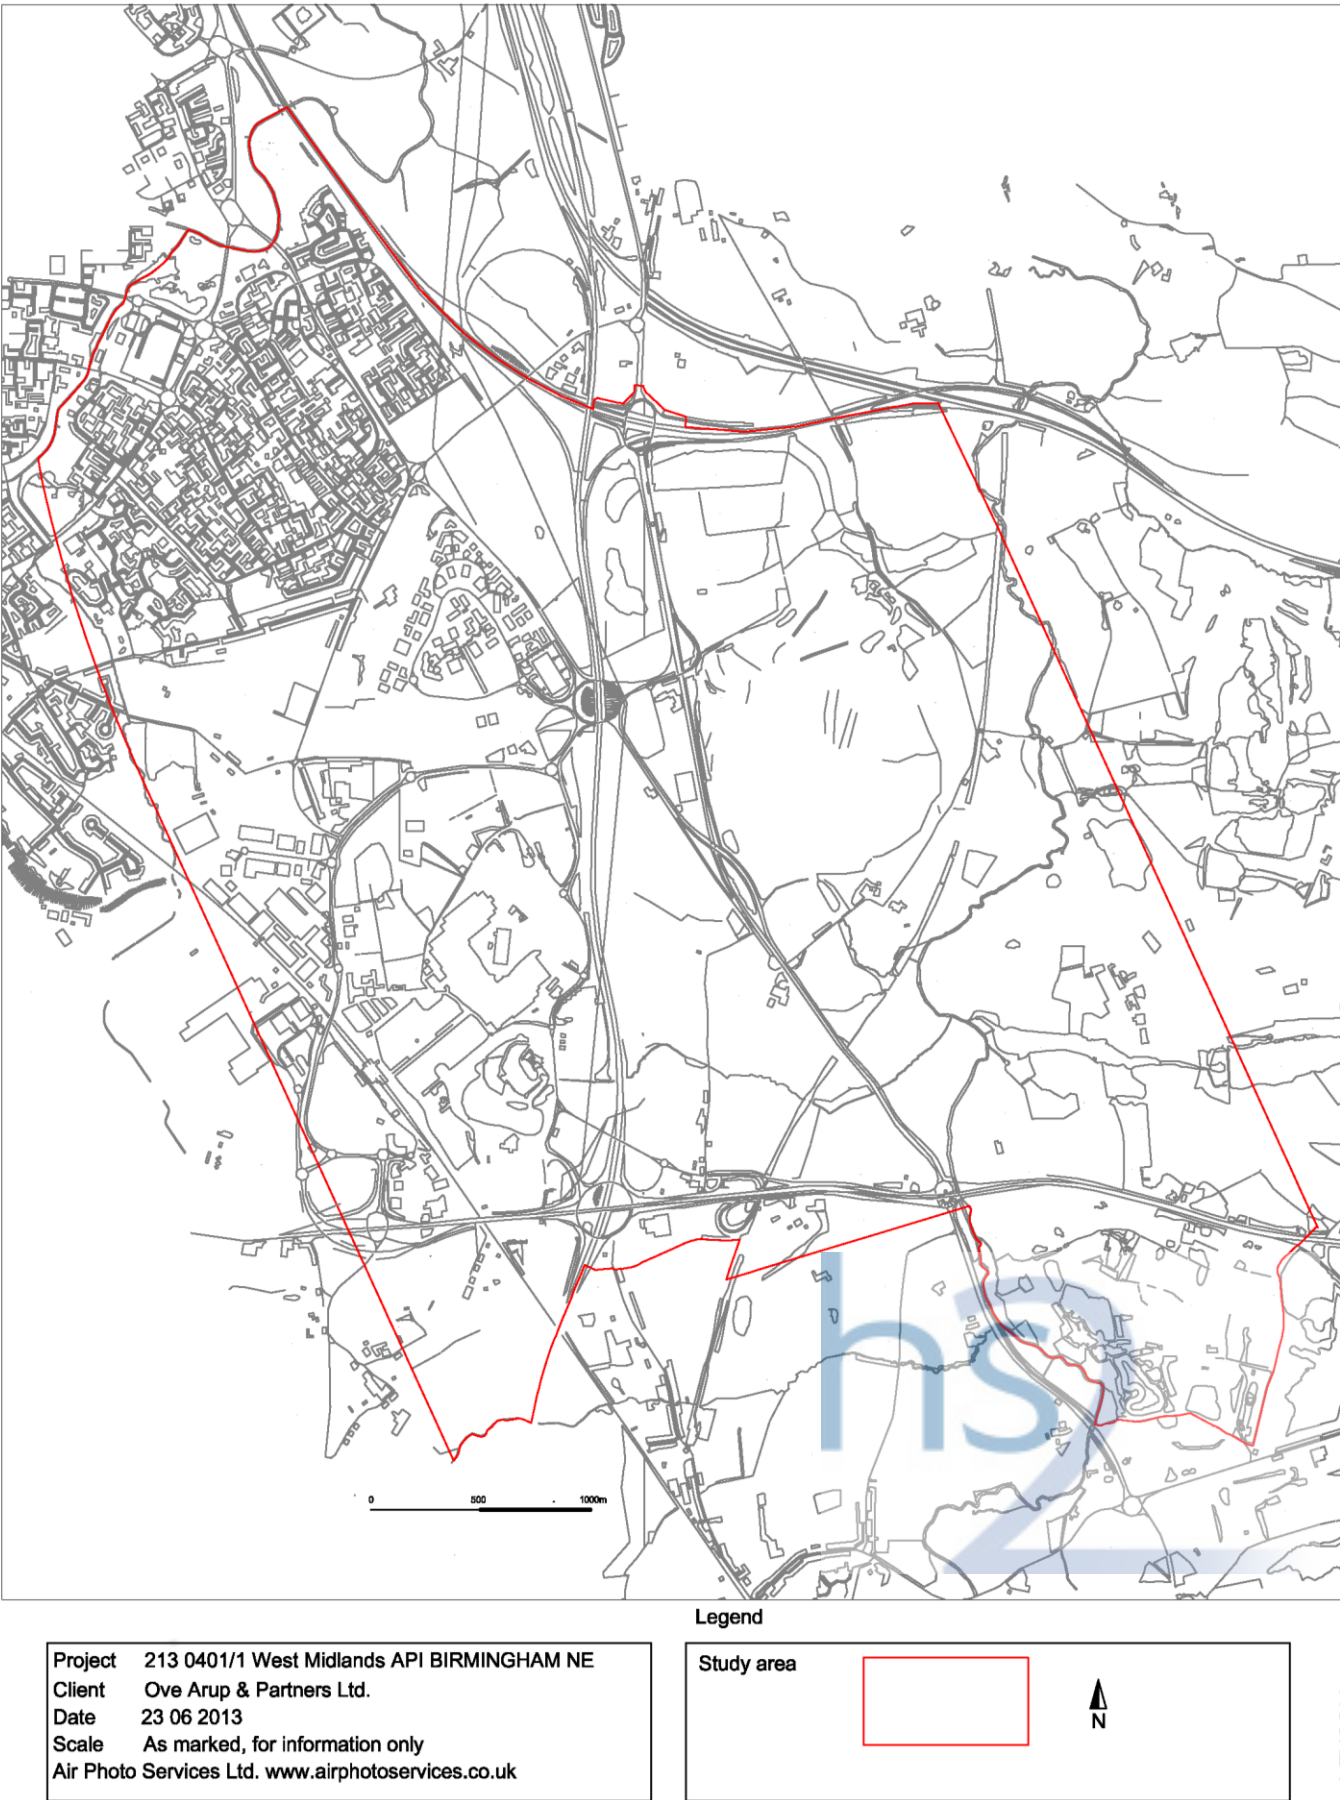
Figure 15: Aerial photographic survey - study area

- 5.1.4 All sites have been accurately located to a digital map base (Figure 16) to facilitate further investigation as appropriate.
- 5.1.5 Figure 15 shows the location of the study area.
